26th Congress
86th Annual Meeting
1 - 7 July, Vienna

The Ribeiradio-Ermida multipurpose hydro scheme, explored since 2015, located in Portugal, encompasses two schemes distanced 5 km. Ribeiradio scheme includes a 83 m high concrete gravity dam and underground powerhouse with 74,5 MW installed capacity.

This paper presents the general conception for the dam foundation treatment. Necessary adaptations introduced during the execution stage, to deal with geological, geotechnical and hydrogeological constraints found, essentially associated to geological faults, are also mentioned.

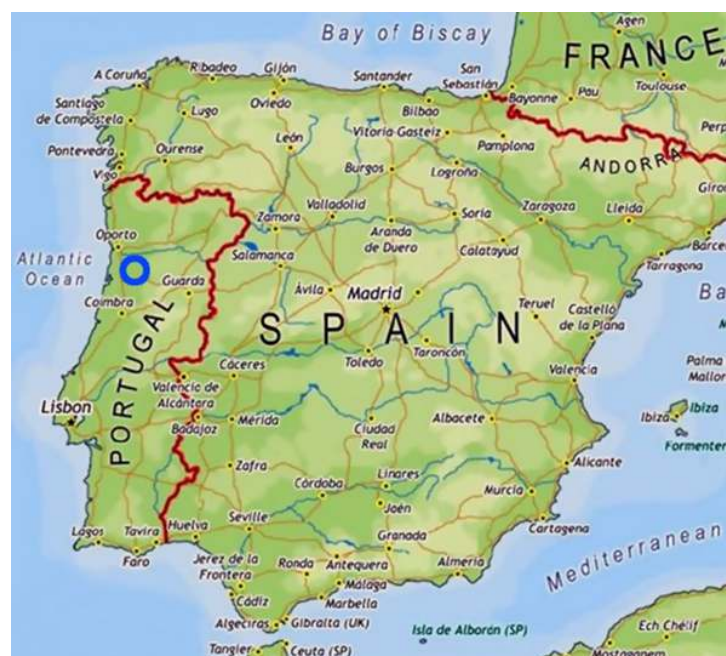
Fig. 1
Location of Ribeiradio and Ermida hydroelectric schemes
Emplacement des projets hydroélectriques Ribeiradio et Ermida

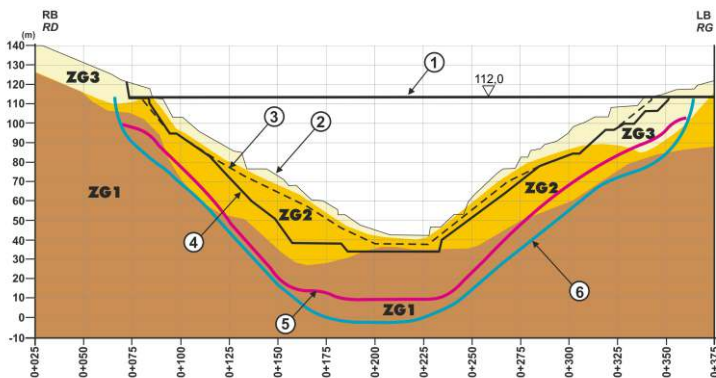
Fig. 4

Geotechnical zoning. Foundation surface. Ground treatment
Zonage géotechnique. Surface de fondation. Traitement de fondation

It was essential to limit the excavation depth to values compatible with the height and type of dam, consequently it was decided that most of the dam foundation surface would be set on GZ2 rock mass showing RMR values between 40 and 60 (fair quality). This design conception led to estimated excavations depths of 5-7 m on the central zone of the valley, 8-10 m along intermediate levels of both banks and 12-15 m above level (90) on both banks (see Figure 4).

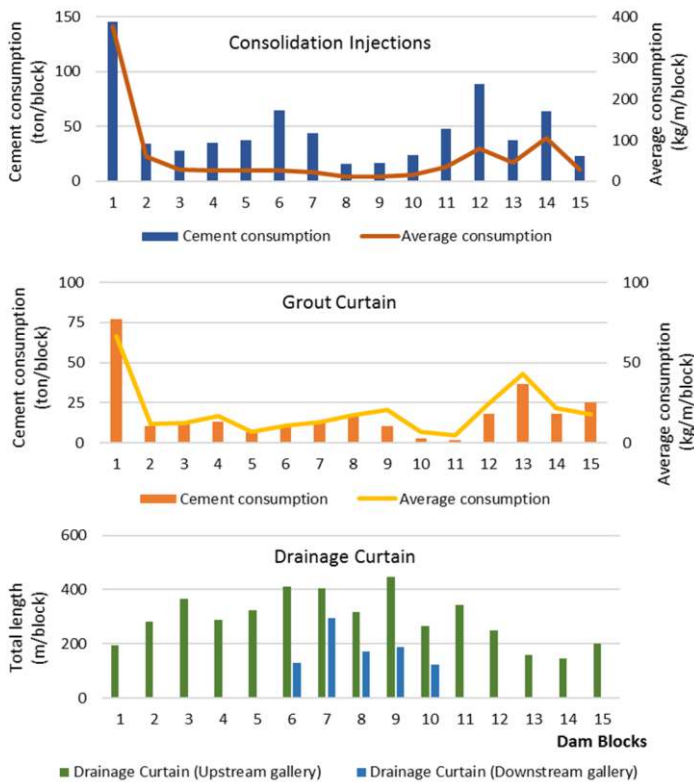
Fig. 11
Main quantities of ground treatment of Ribeiradio dam foundation
Principales quantidades de tratamento de la fundação do barragem de Ribeiradio

Figure 11 shows the grout take quantities for each dam block as well as the total drilling for the drainage curtain.

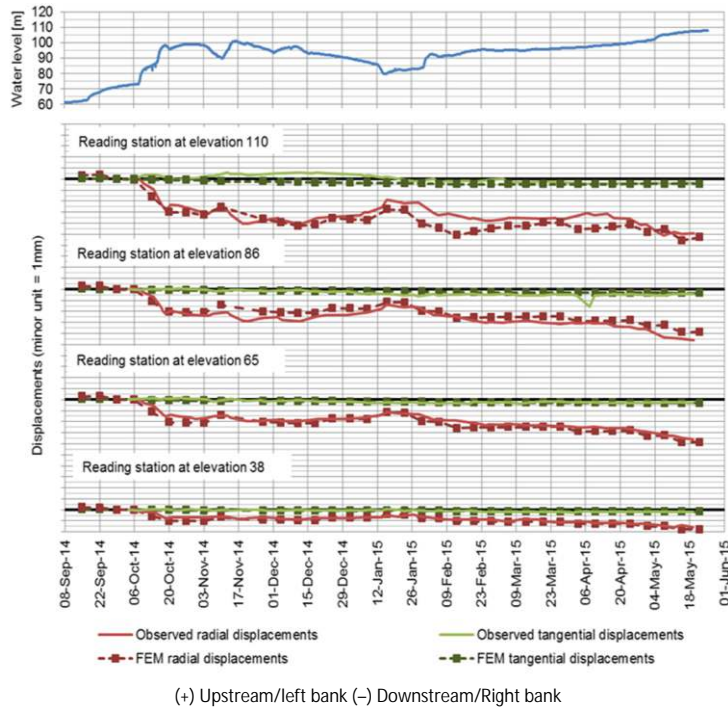
Fig. 14

Comparison of calculated and measured radial displacements in the central plumb line FPI 2 (block 8)

Figure 14 compares the results obtained in the numerical model simulation with the values of the displacements observed at the different reading stations of the plumb line FPI2. The analysis of this figure shows that, in general, there is a good agreement between the computed results and the observed values. The worse agreement between both values is observed in the higher reading station, and was attributed to this reading station being located in the spillway walls and not in the dam body. Not only the pier is much more flexible than the block, but also, during the considered period, works in the gates of the dam were carried out.

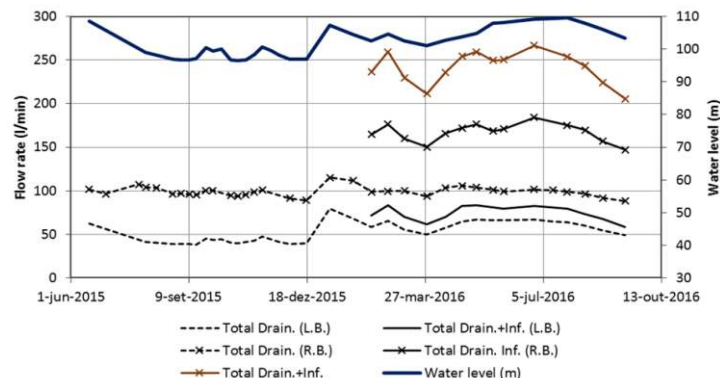
Fig. 15

Flows seepage rates throughout Ribeiradio dam foundation after the first filling
Débit d'infiltration à travers de la fondation du barrage de Ribeiradio après le premier remplissage

Since the drainage system was only fully completed by the end of the first quarter of 2015, the total flow meters could only be observed in early 2016. Figure 15 shows the evolution of the flows by margin and total flows in the dam that were observed during the first year after the end of the filling.

On the blocks located on the right bank, for which the foundation had worst geological and geotechnical characteristics, the flows correspond to about twice of those observed in the left bank. The observed uplift pressures were also small and correspond to percentages of the upstream hydraulic load that never reach 20%.
